CYCLONE(Buffalo Creek) Bridge

D22 Buffalo Creek Constructed 1928
rehabilitated 1956, it was US 20

EVALUATION OF GALVANIZED AND PAINTED GALVANIZED STEEL PILING

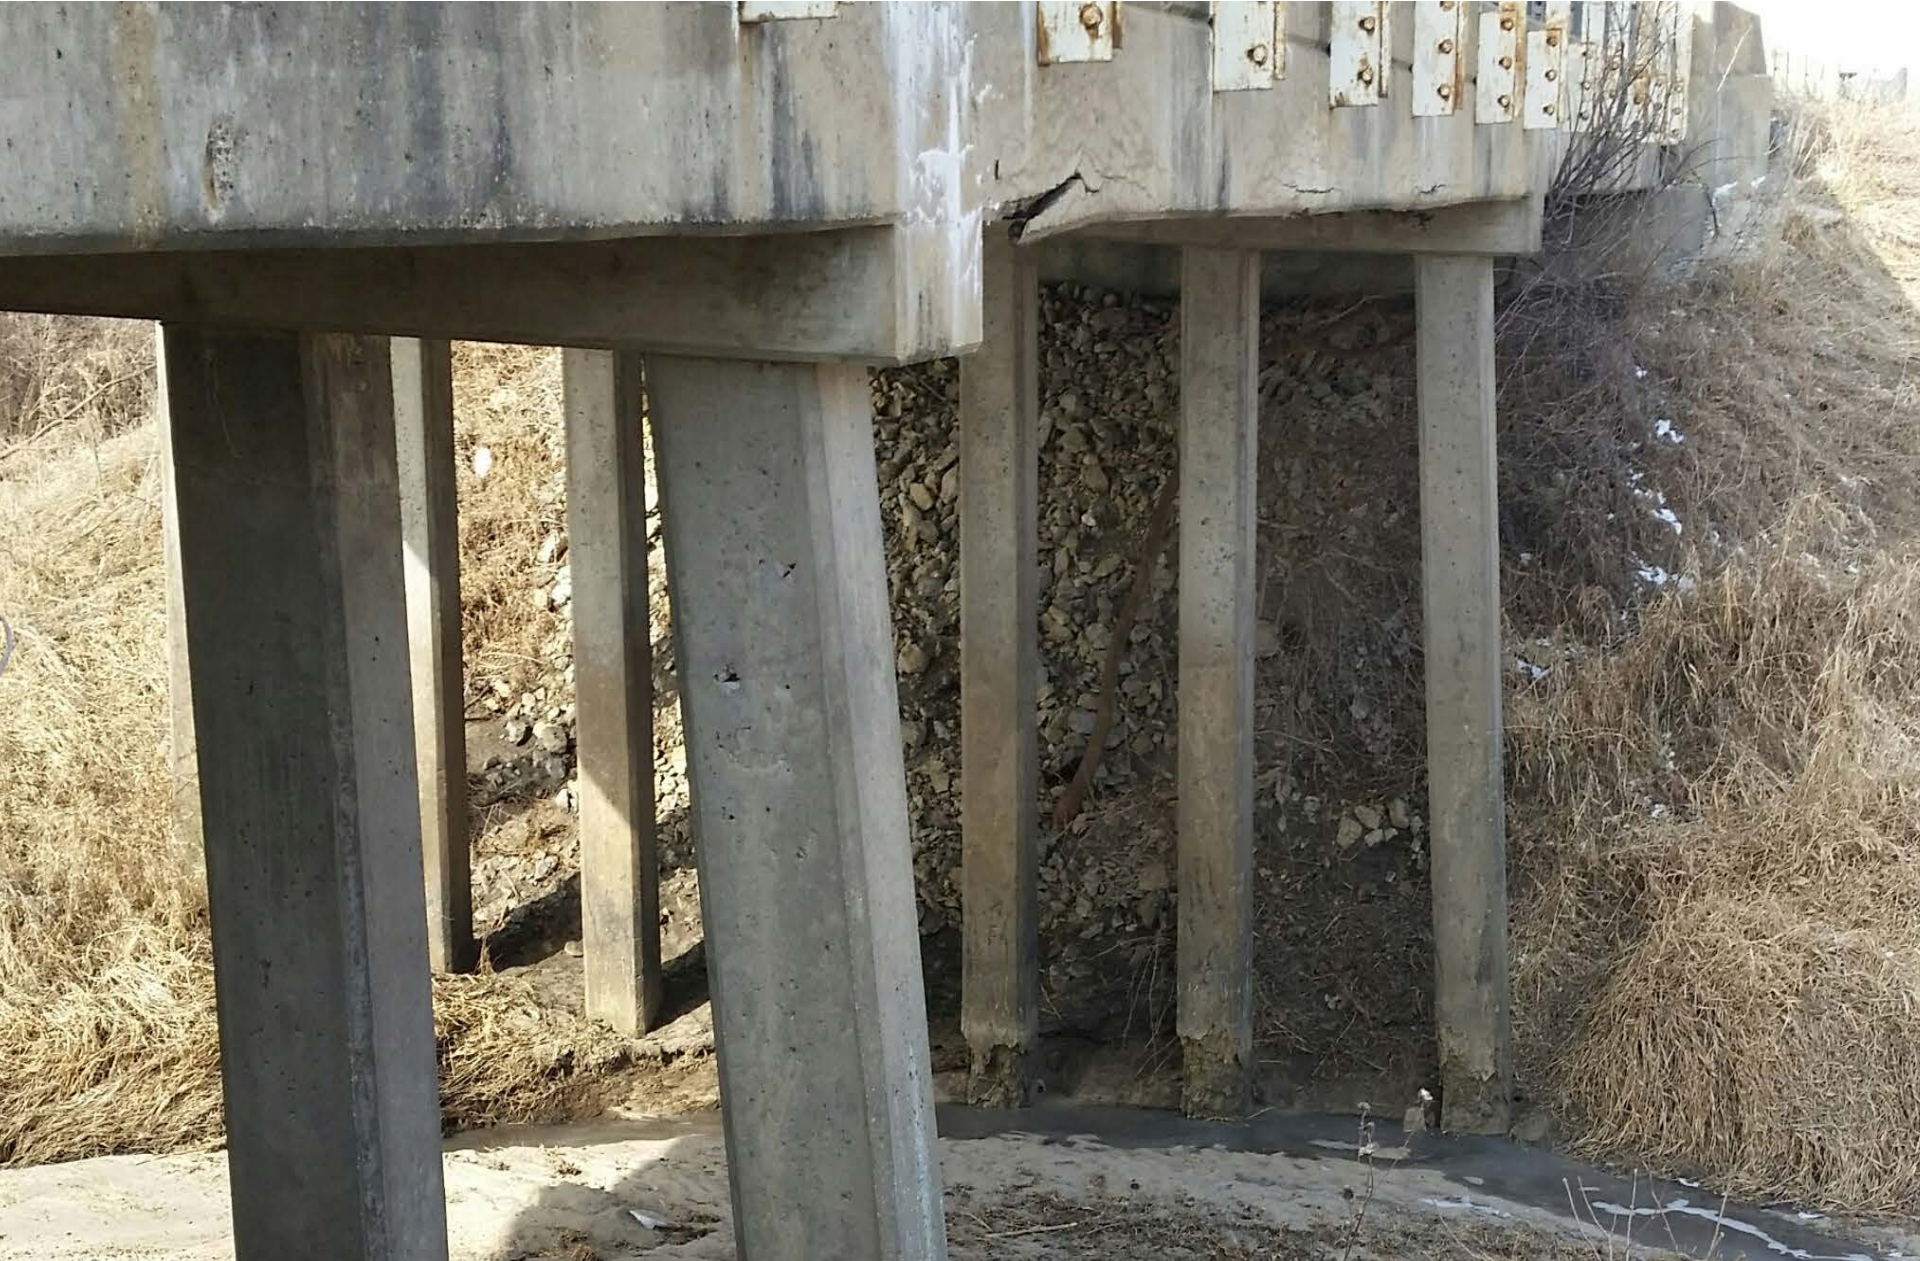
Older encasements

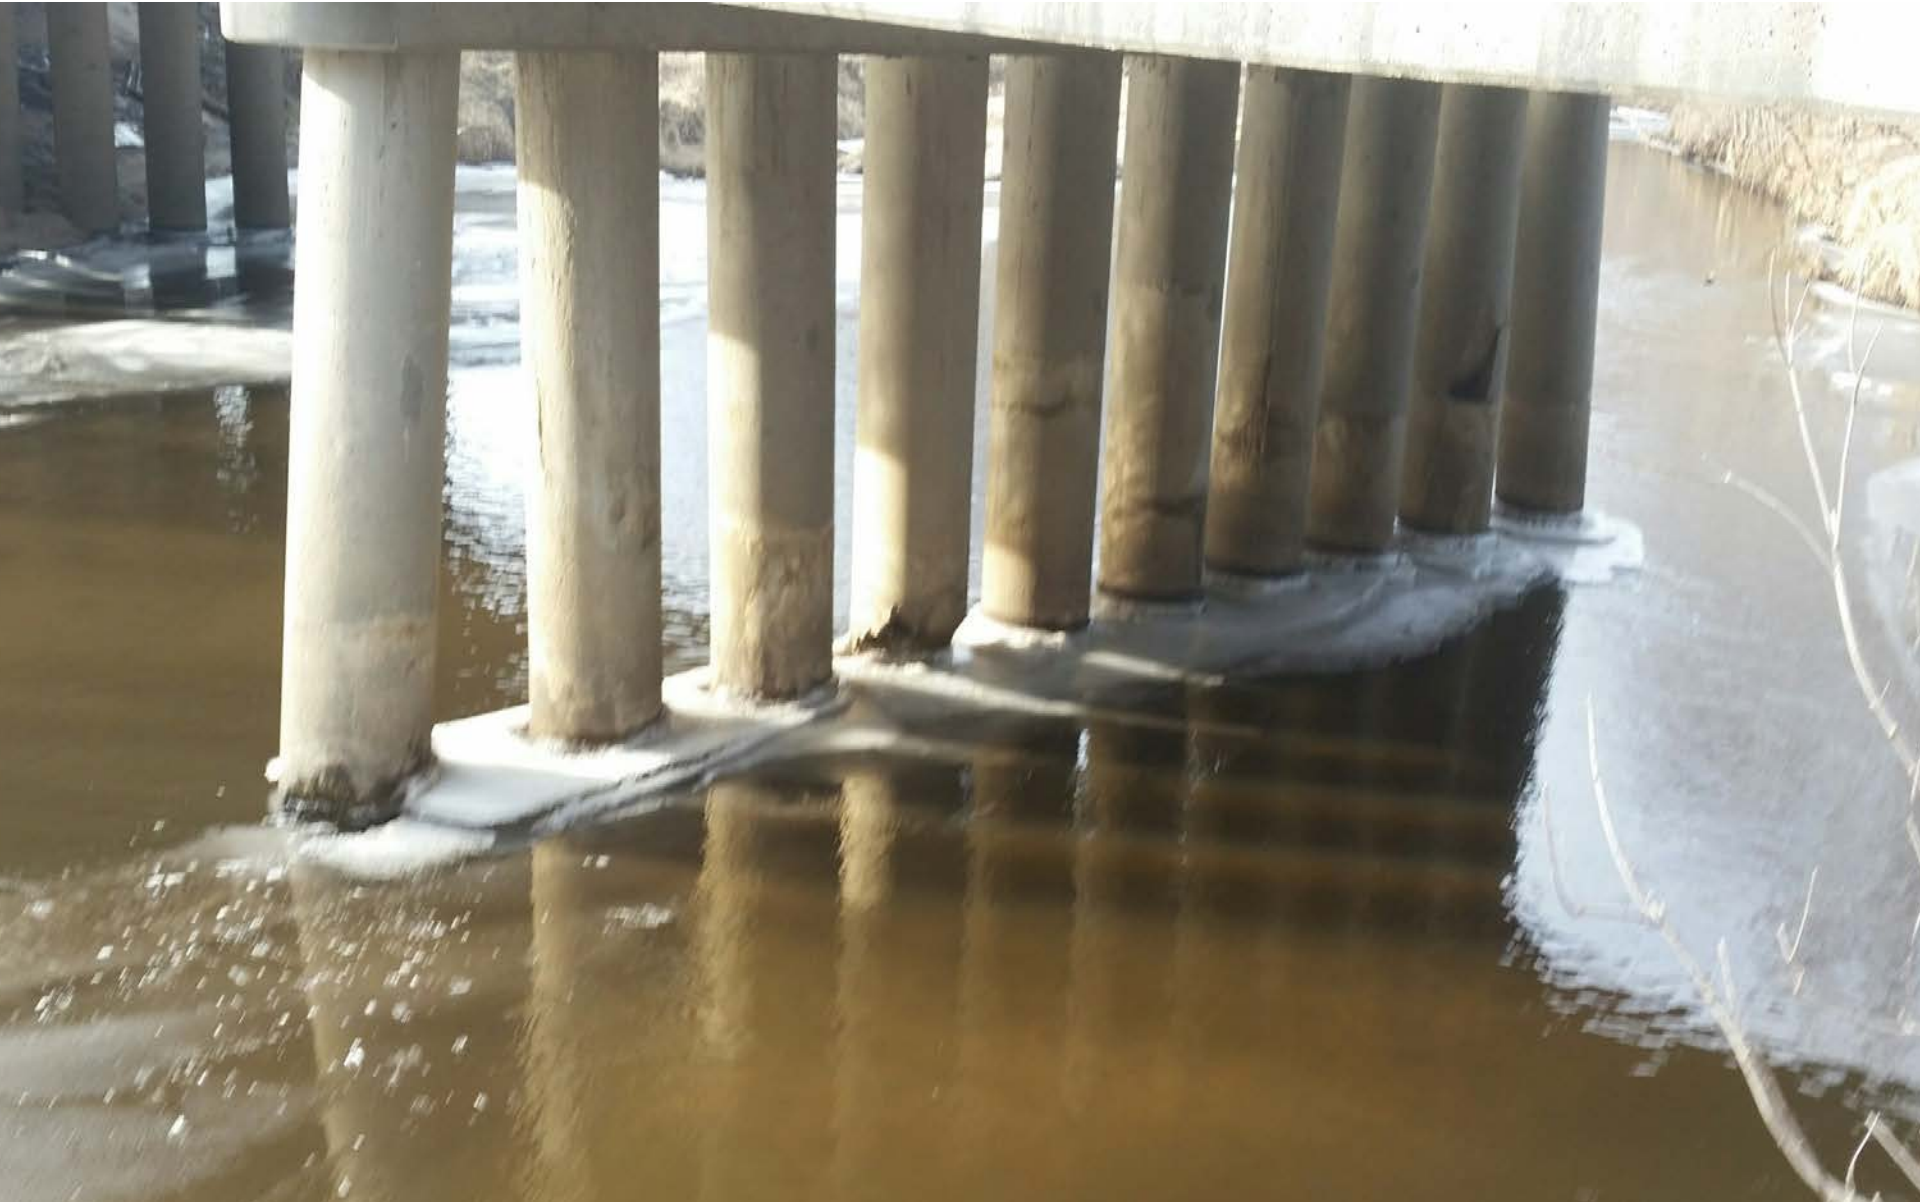
Piling Encasements Deteriorating

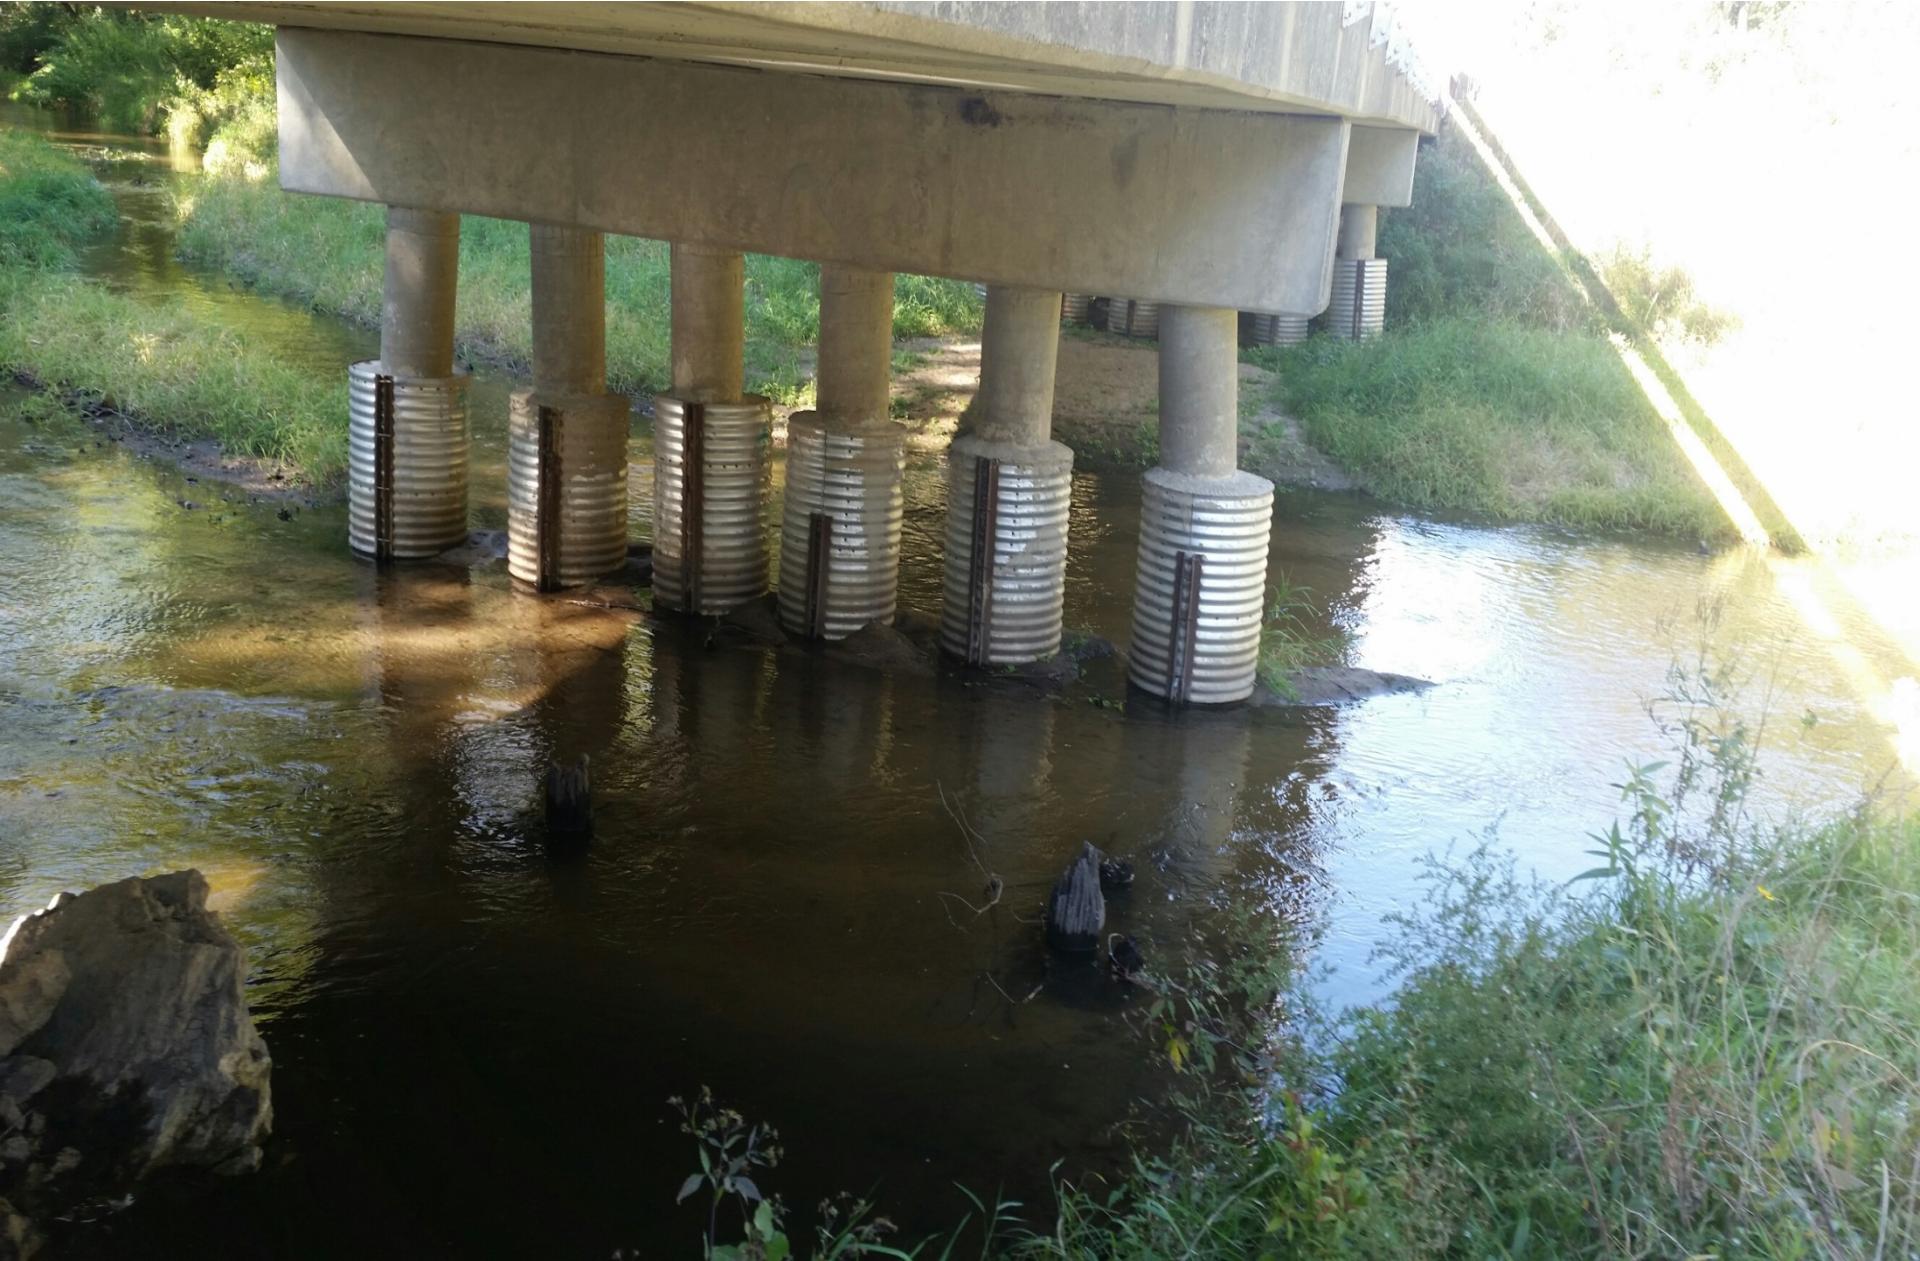
Current Concrete Pier Repair

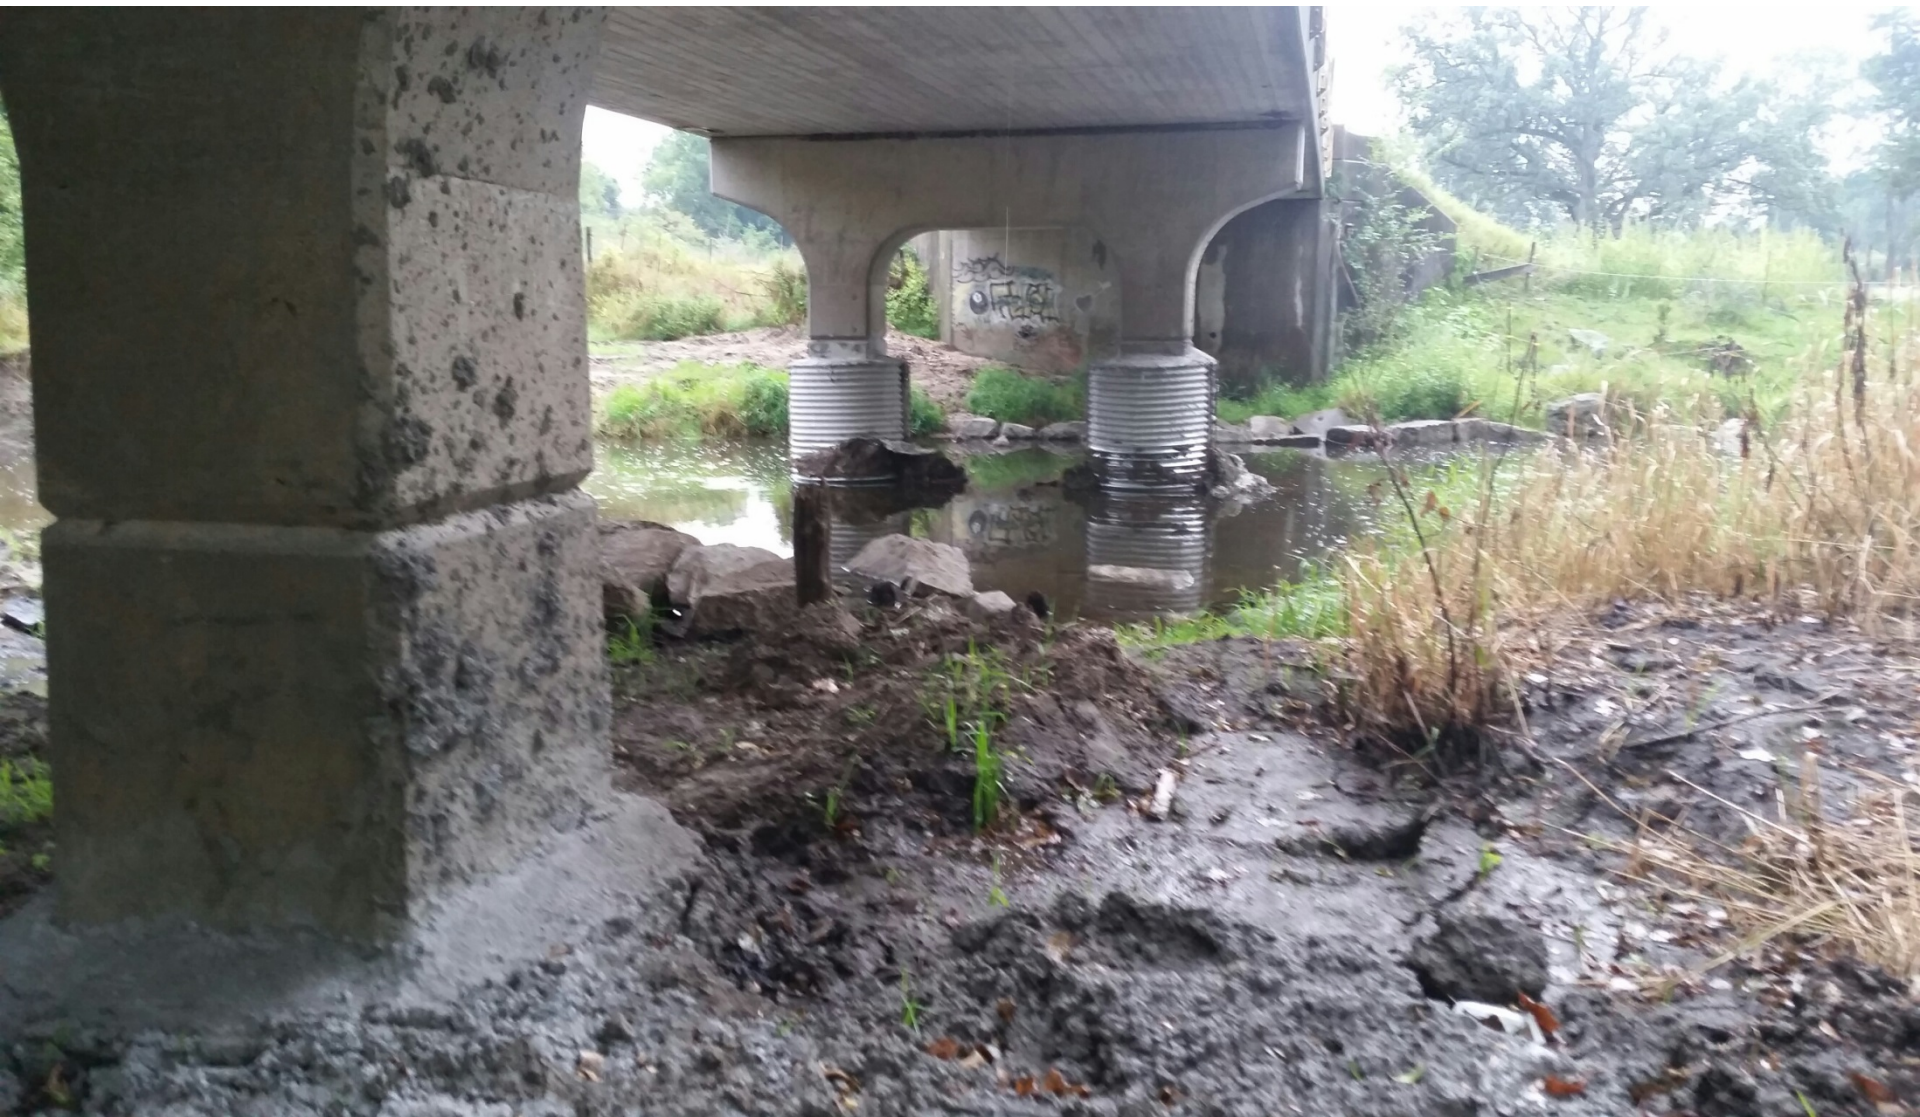
Concrete Pier Repair

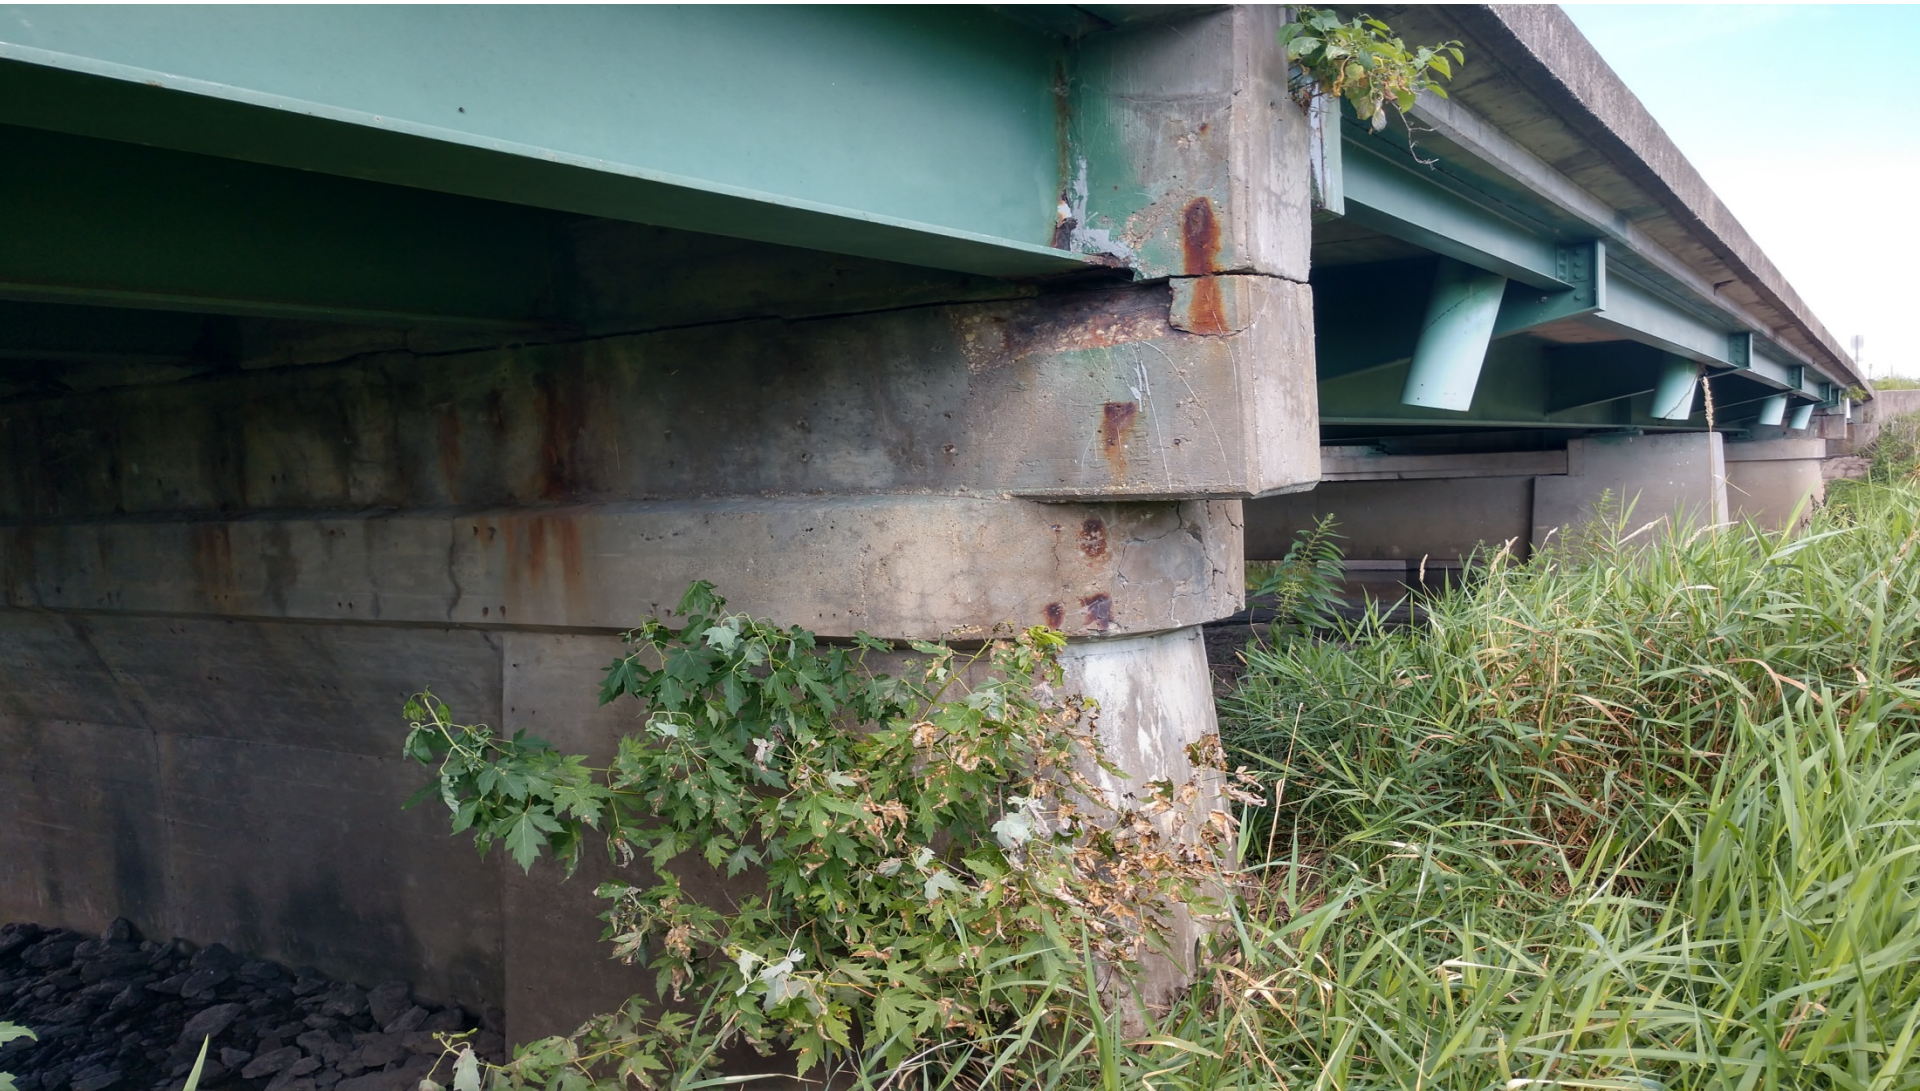
More Substructure issues

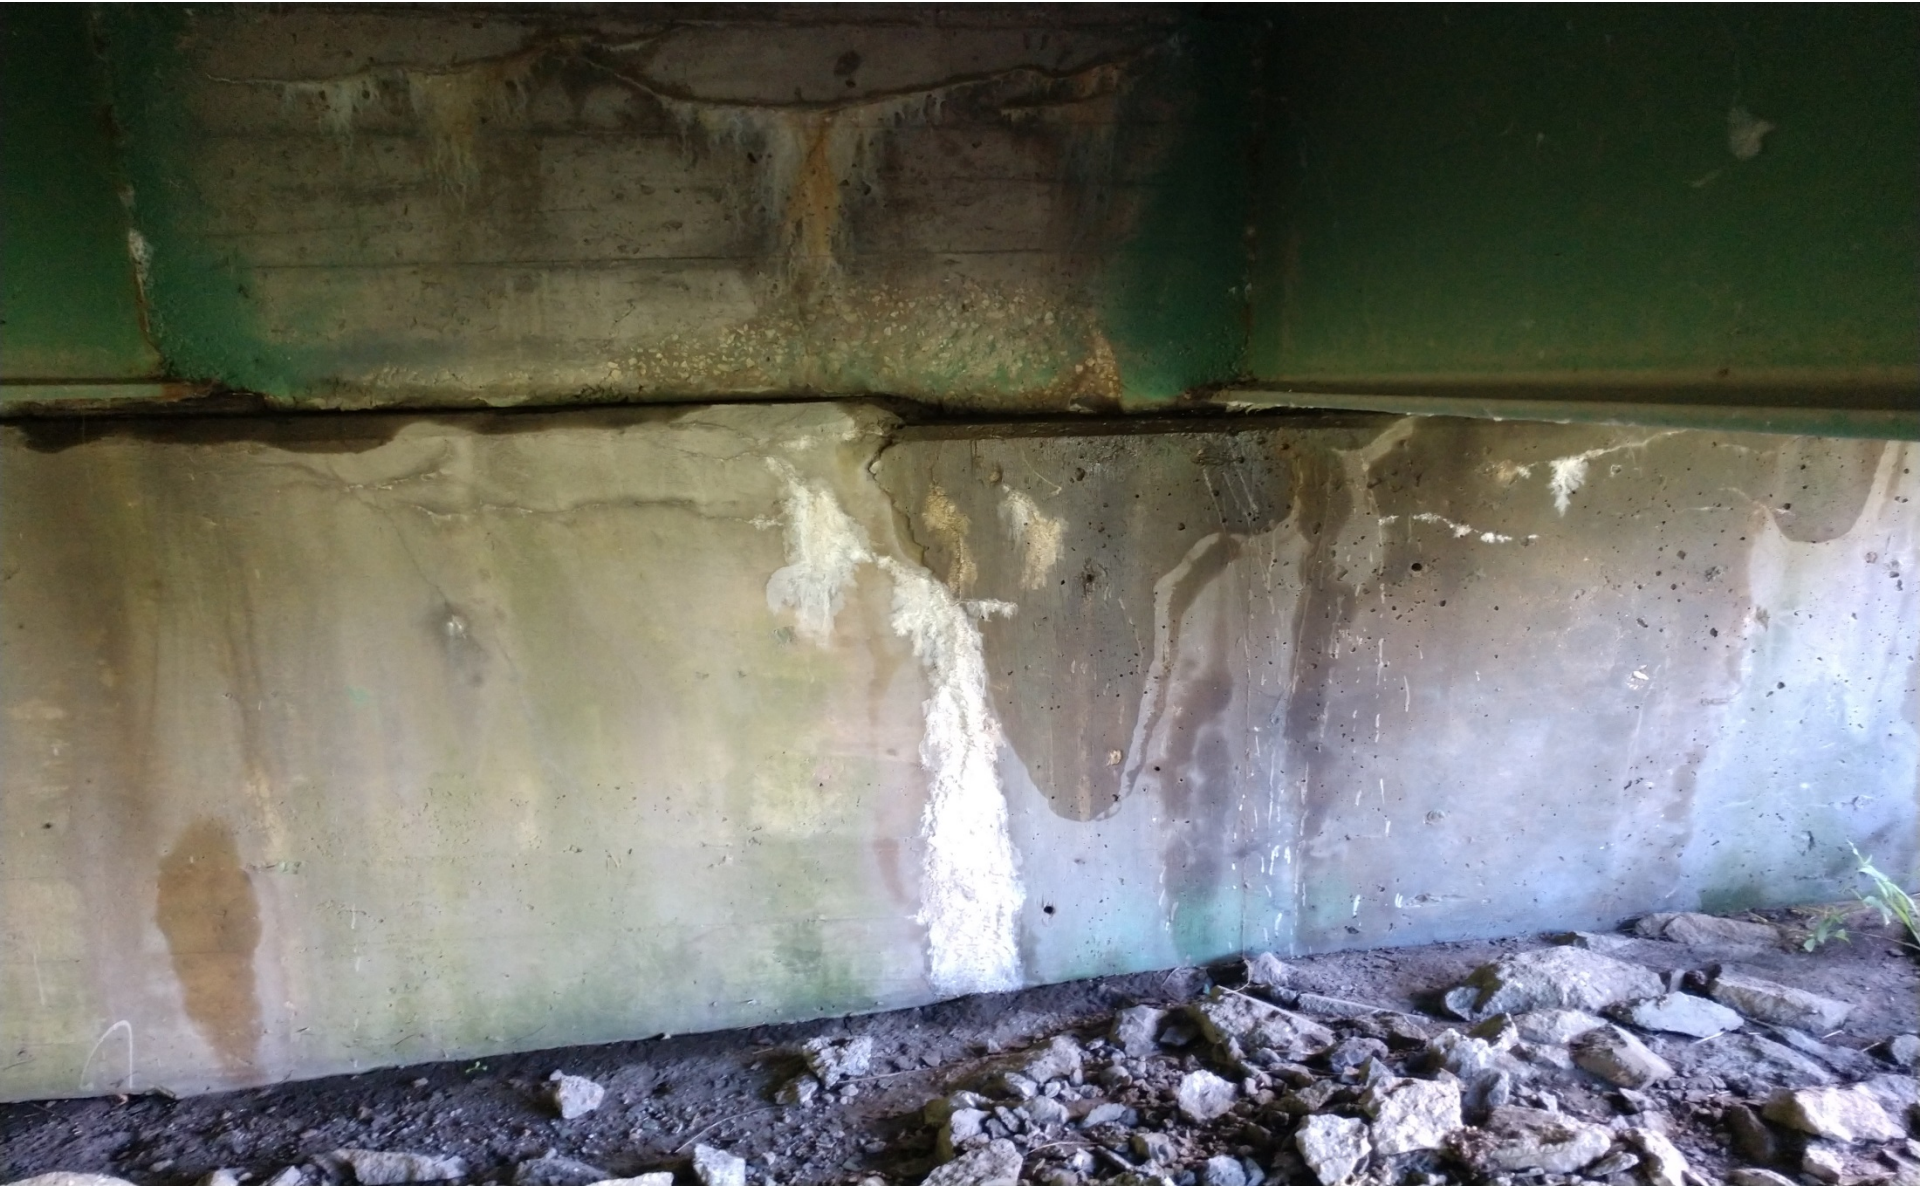
Abutment Fractured and shifting

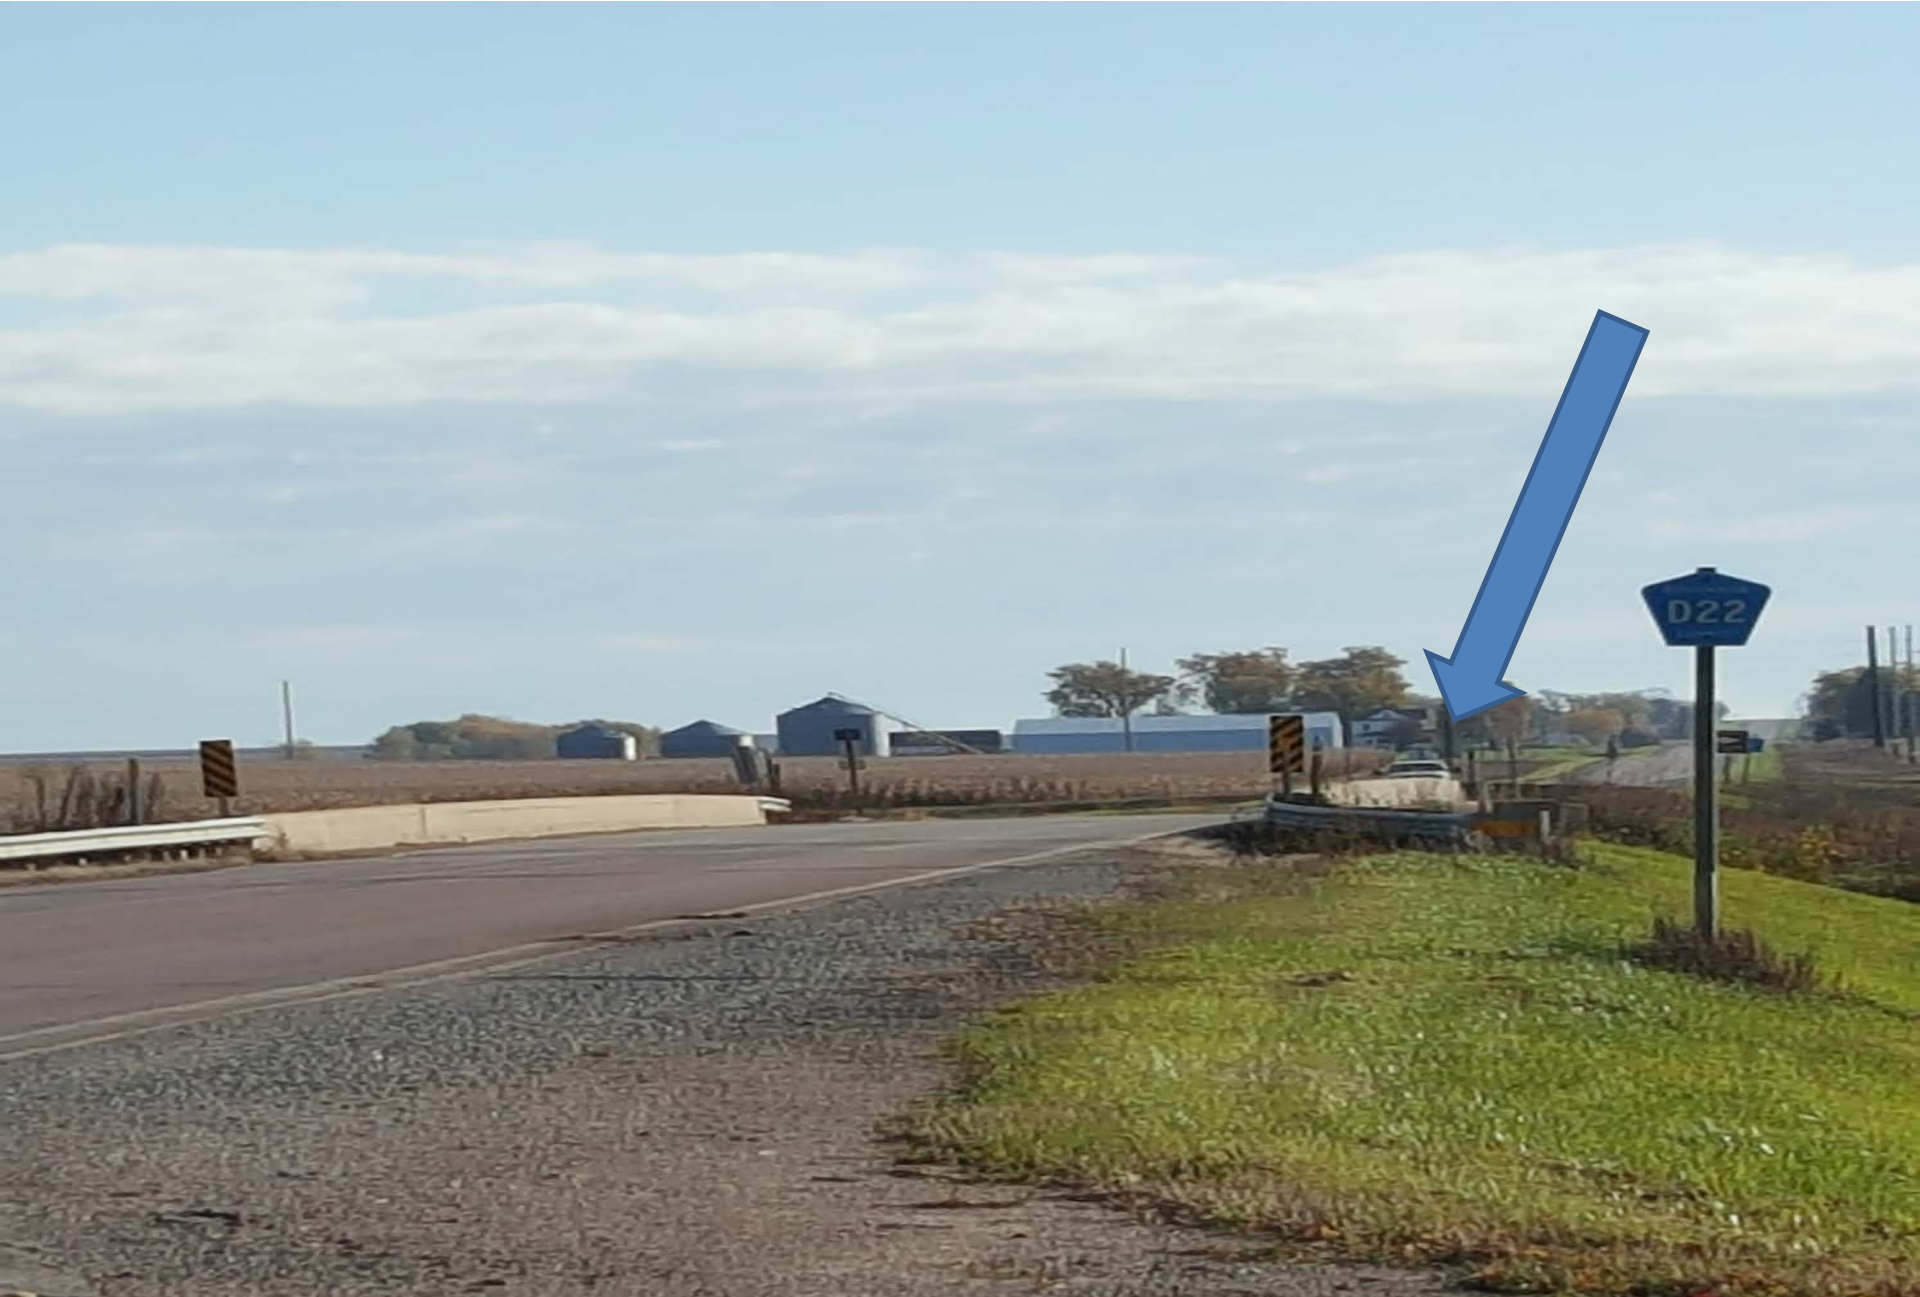
Complaints about visibility

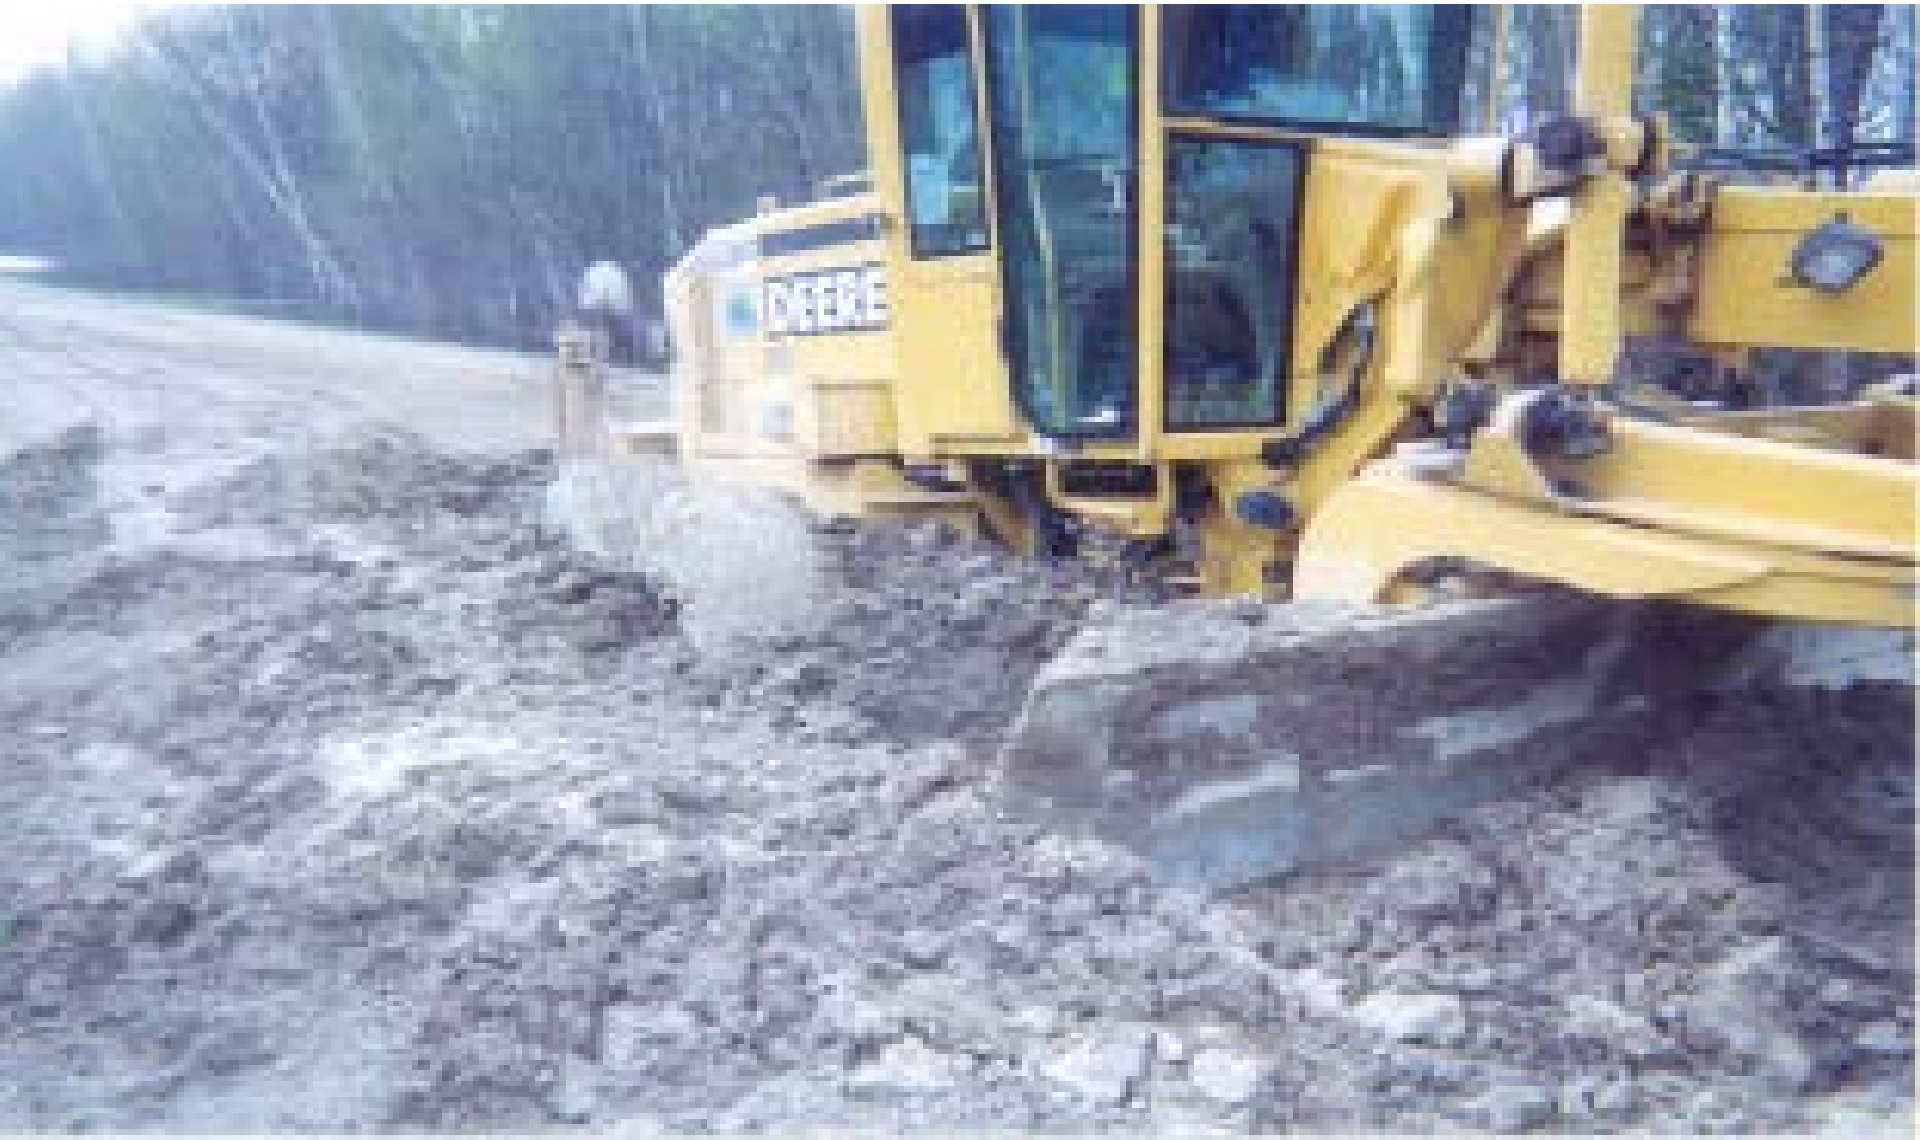
Spring 2019 Frostboils
