CYCLONE(Buffalo Creek) Bridge

D22 Buffalo Creek Constructed 1928
rehabilitated 1956, it was US 20

EVALUATION OF GALVANIZED AND PAINTED GALVANIZED STEEL PILING

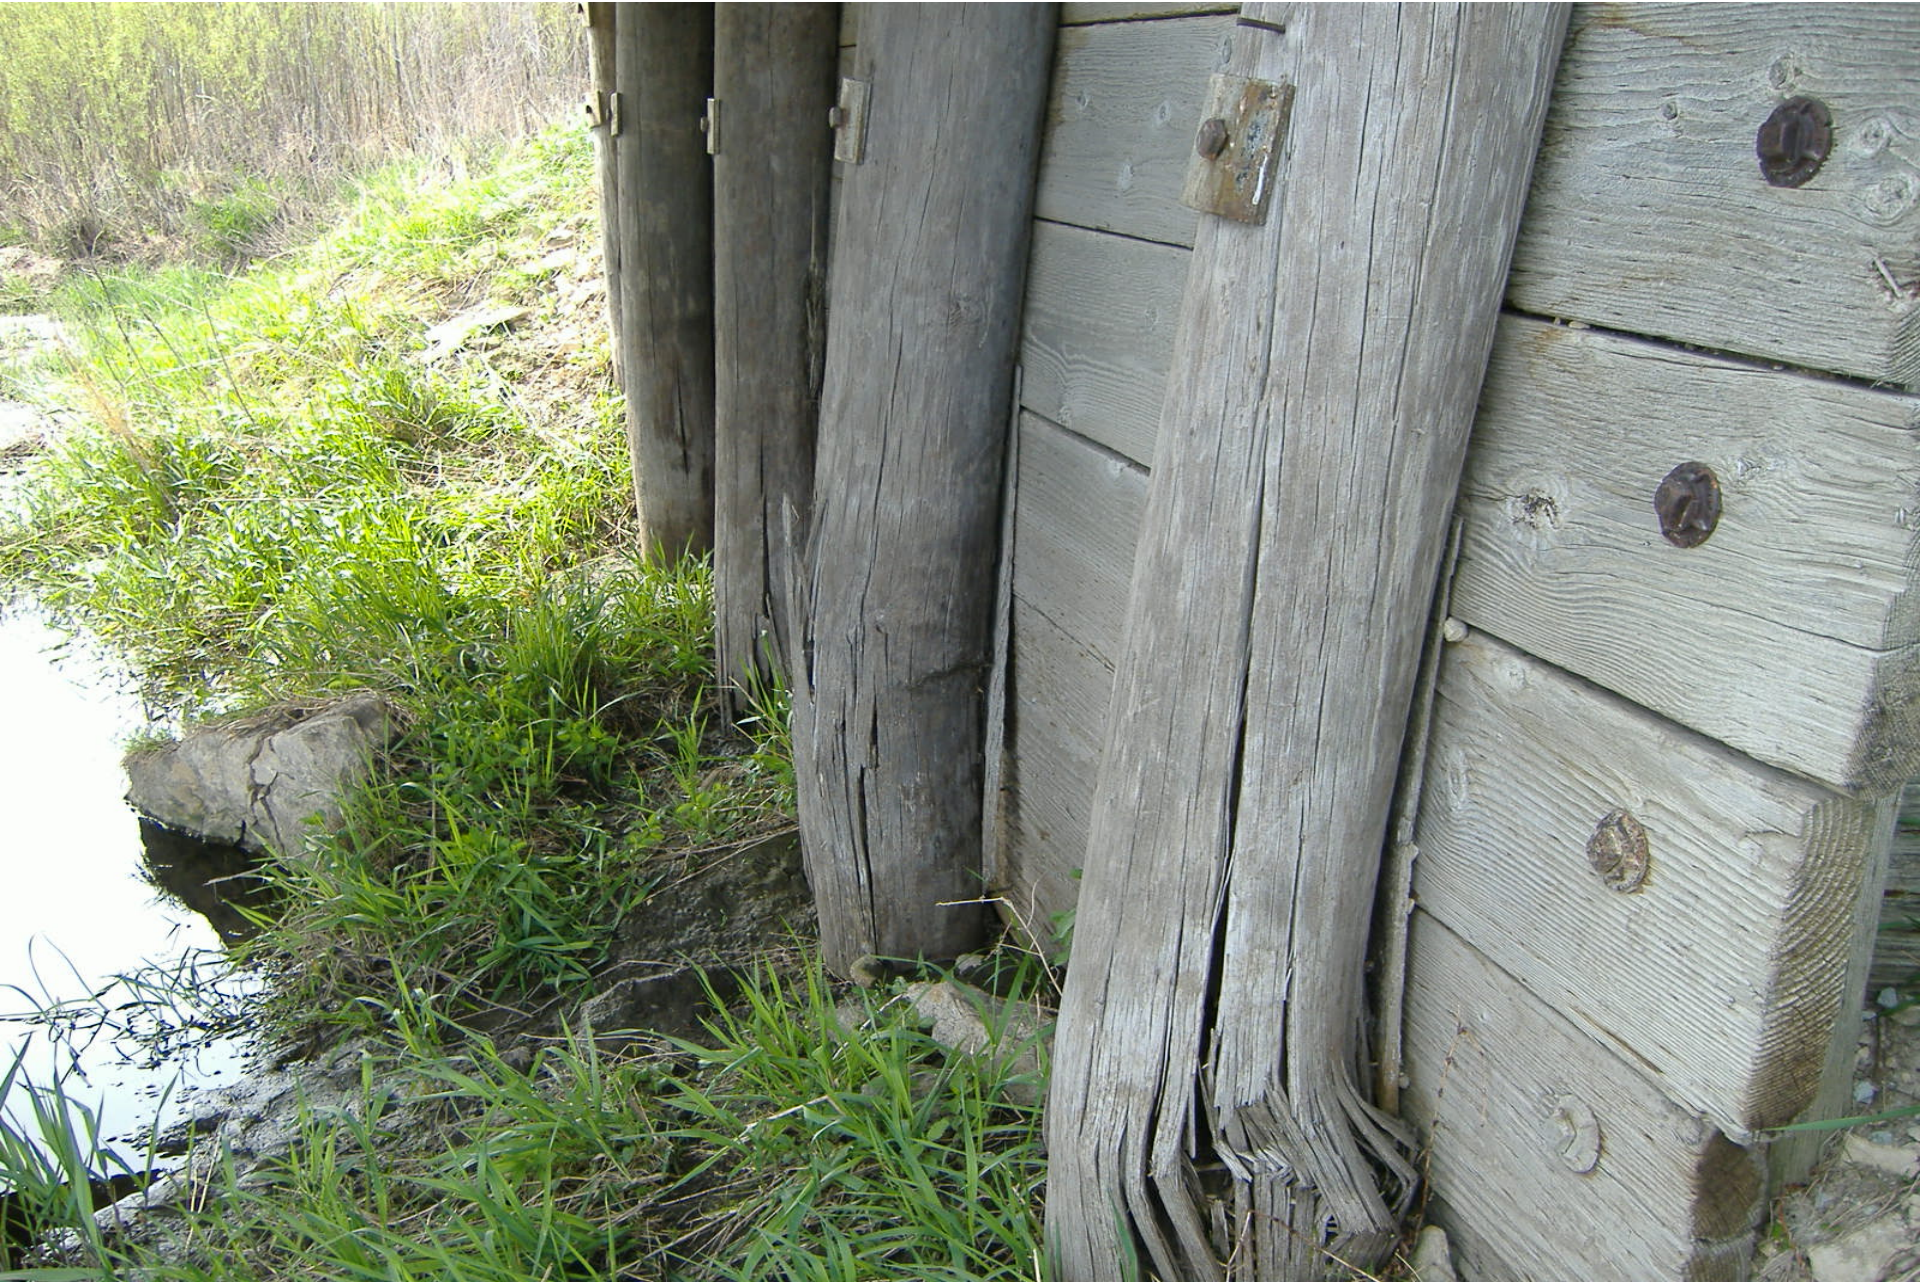
What we are faced with

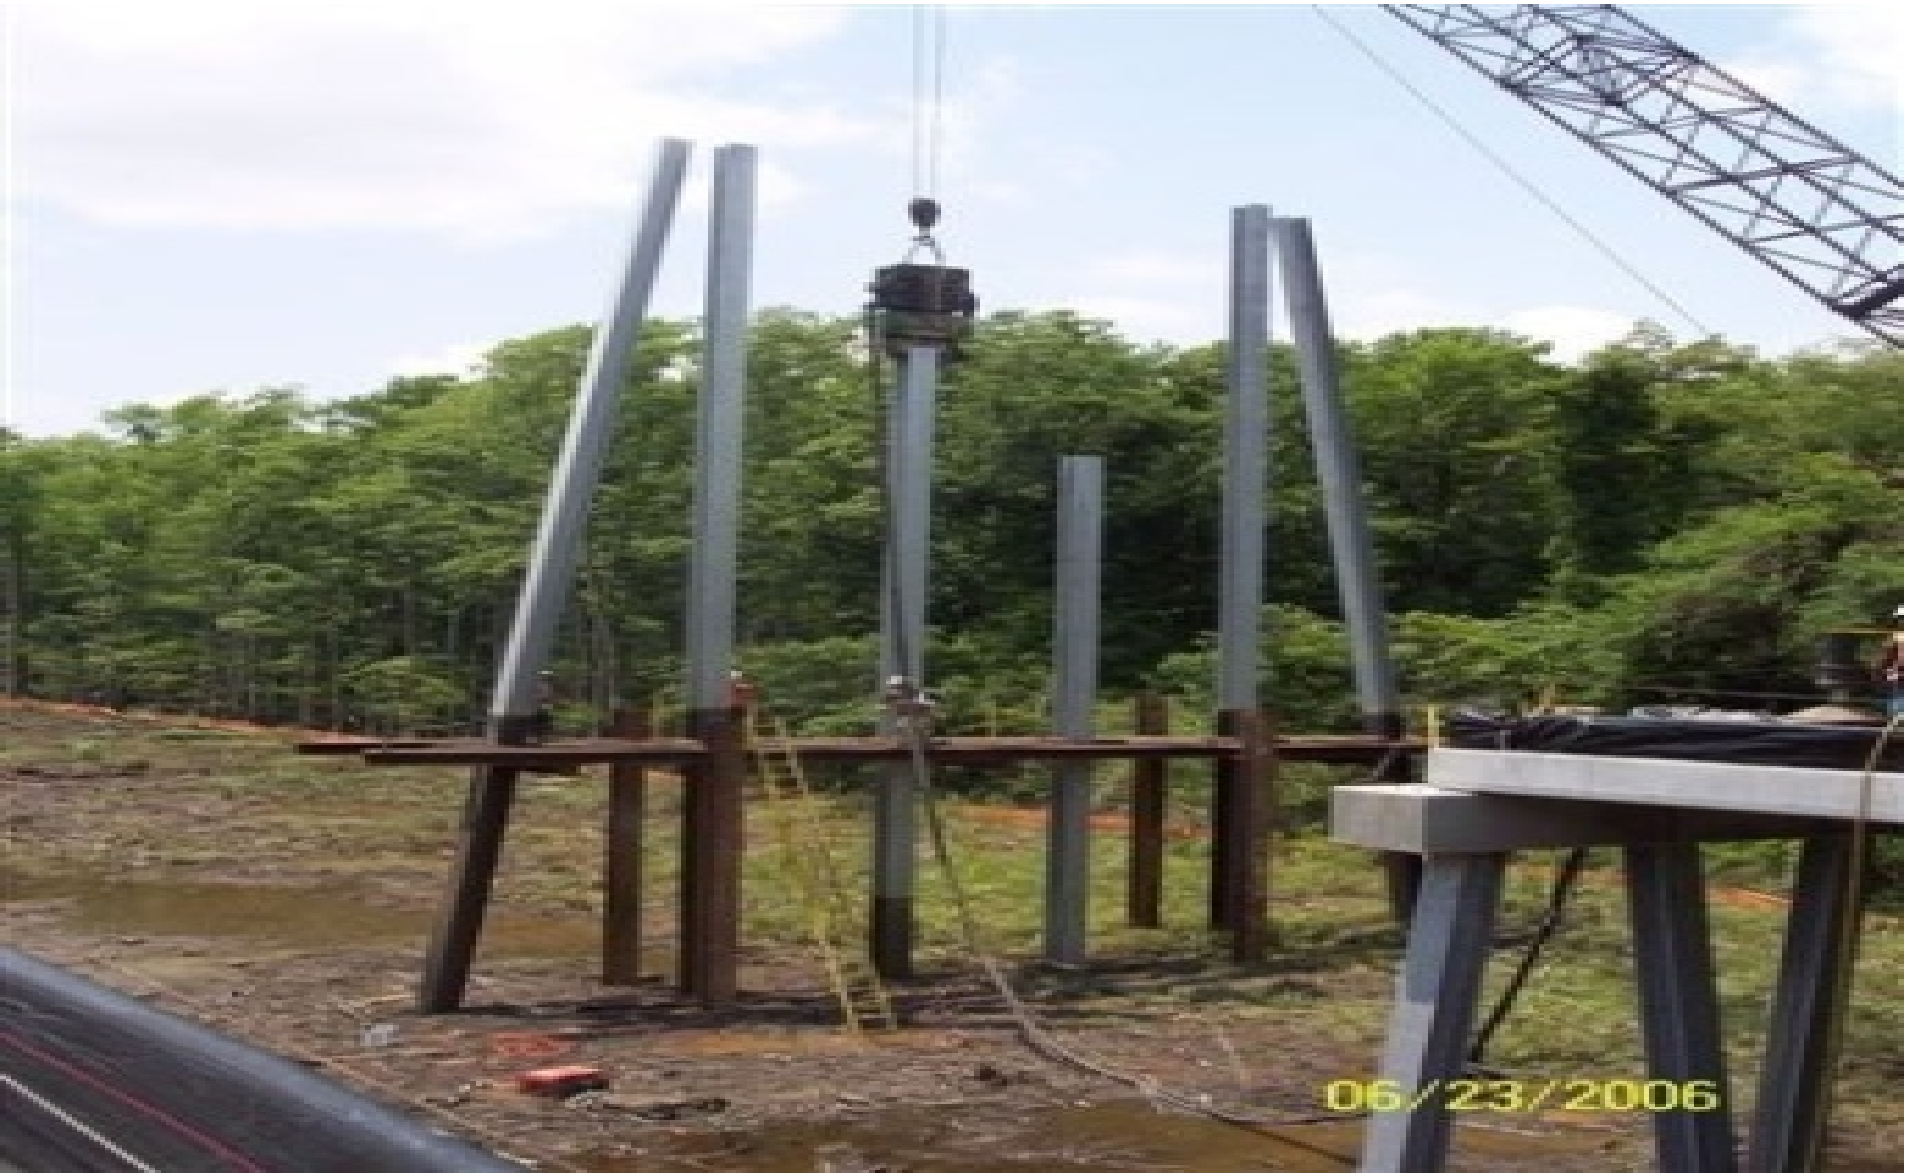
Why not resolve the problem.

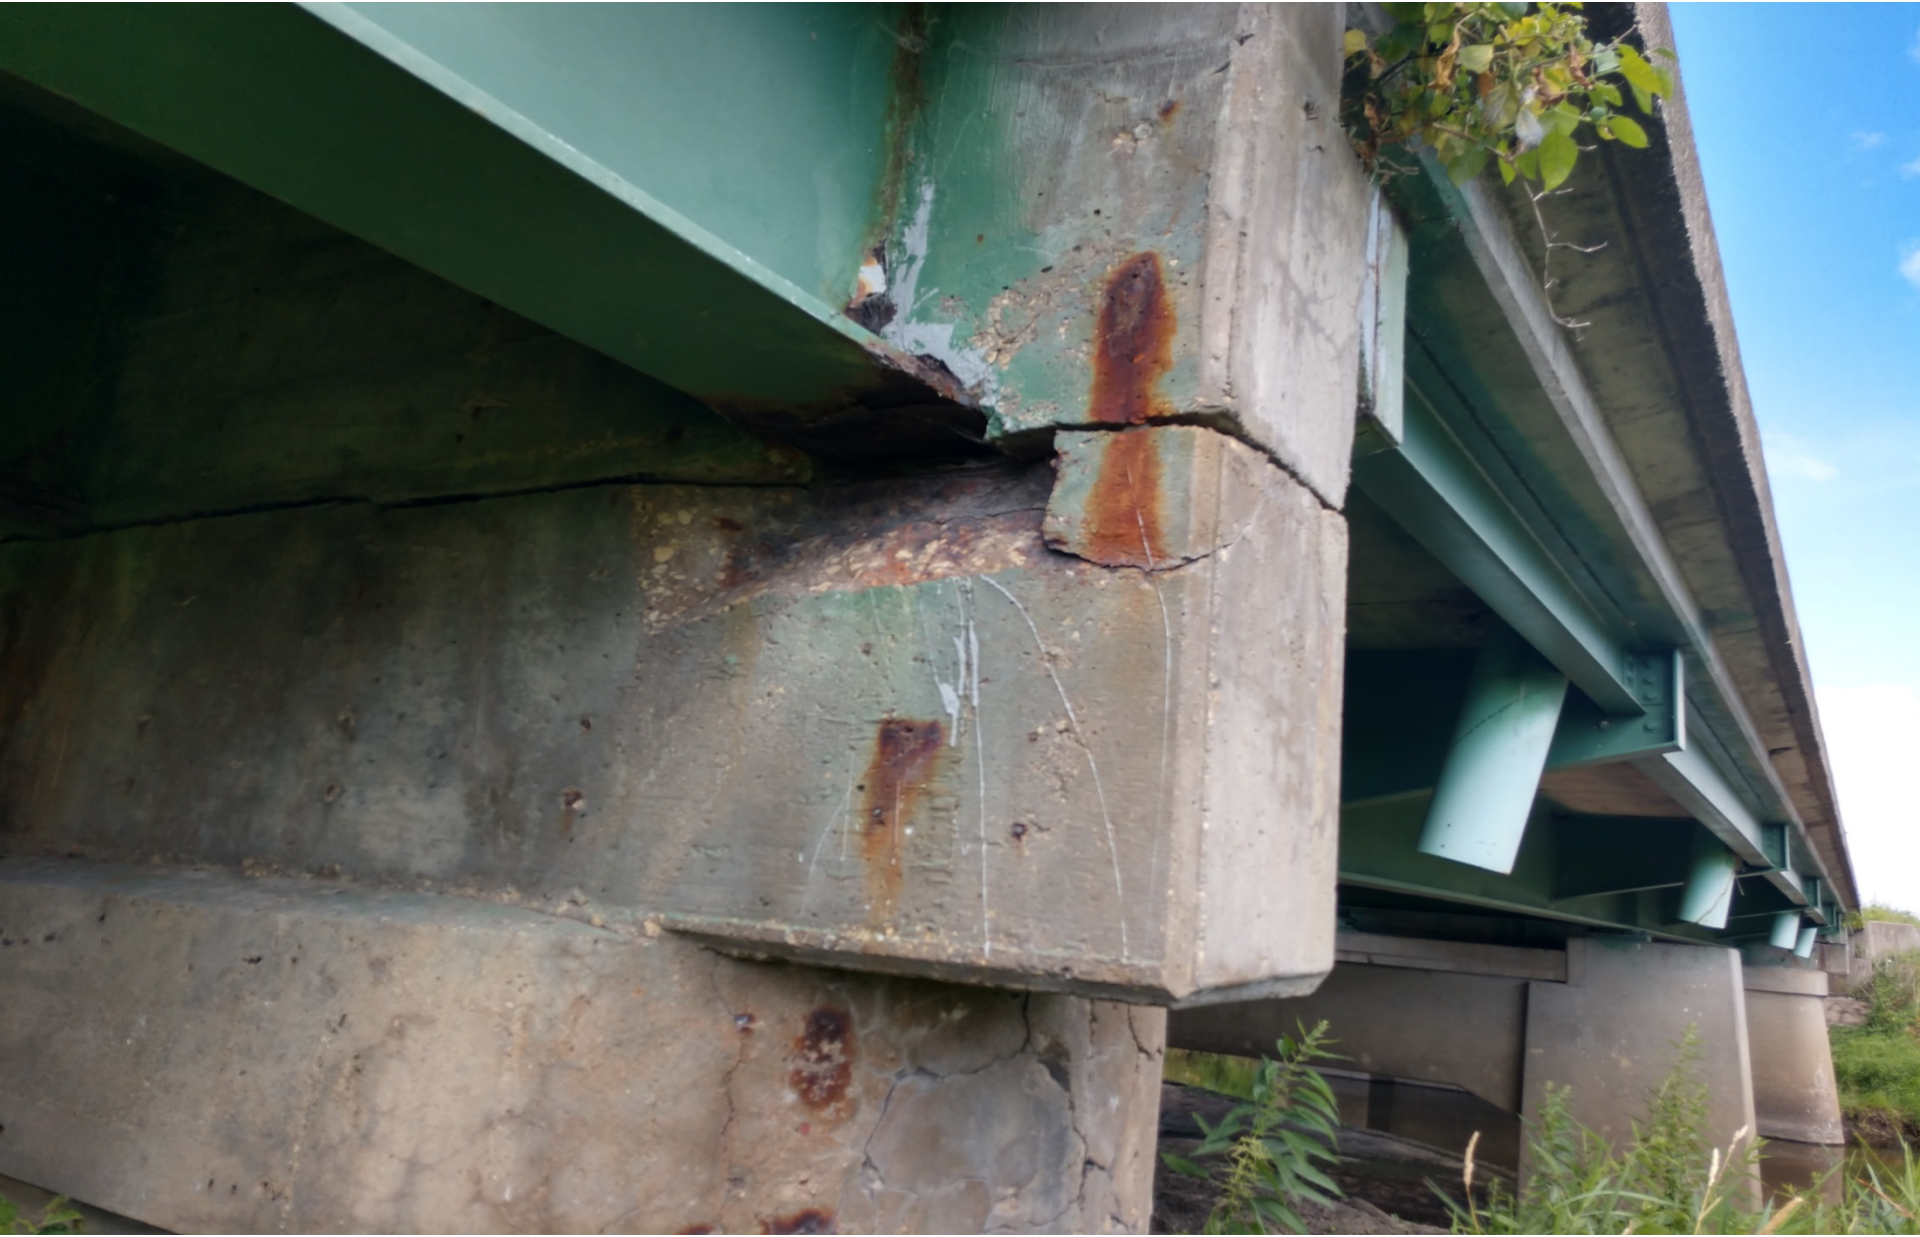
Why replace a perfectly good Bridge

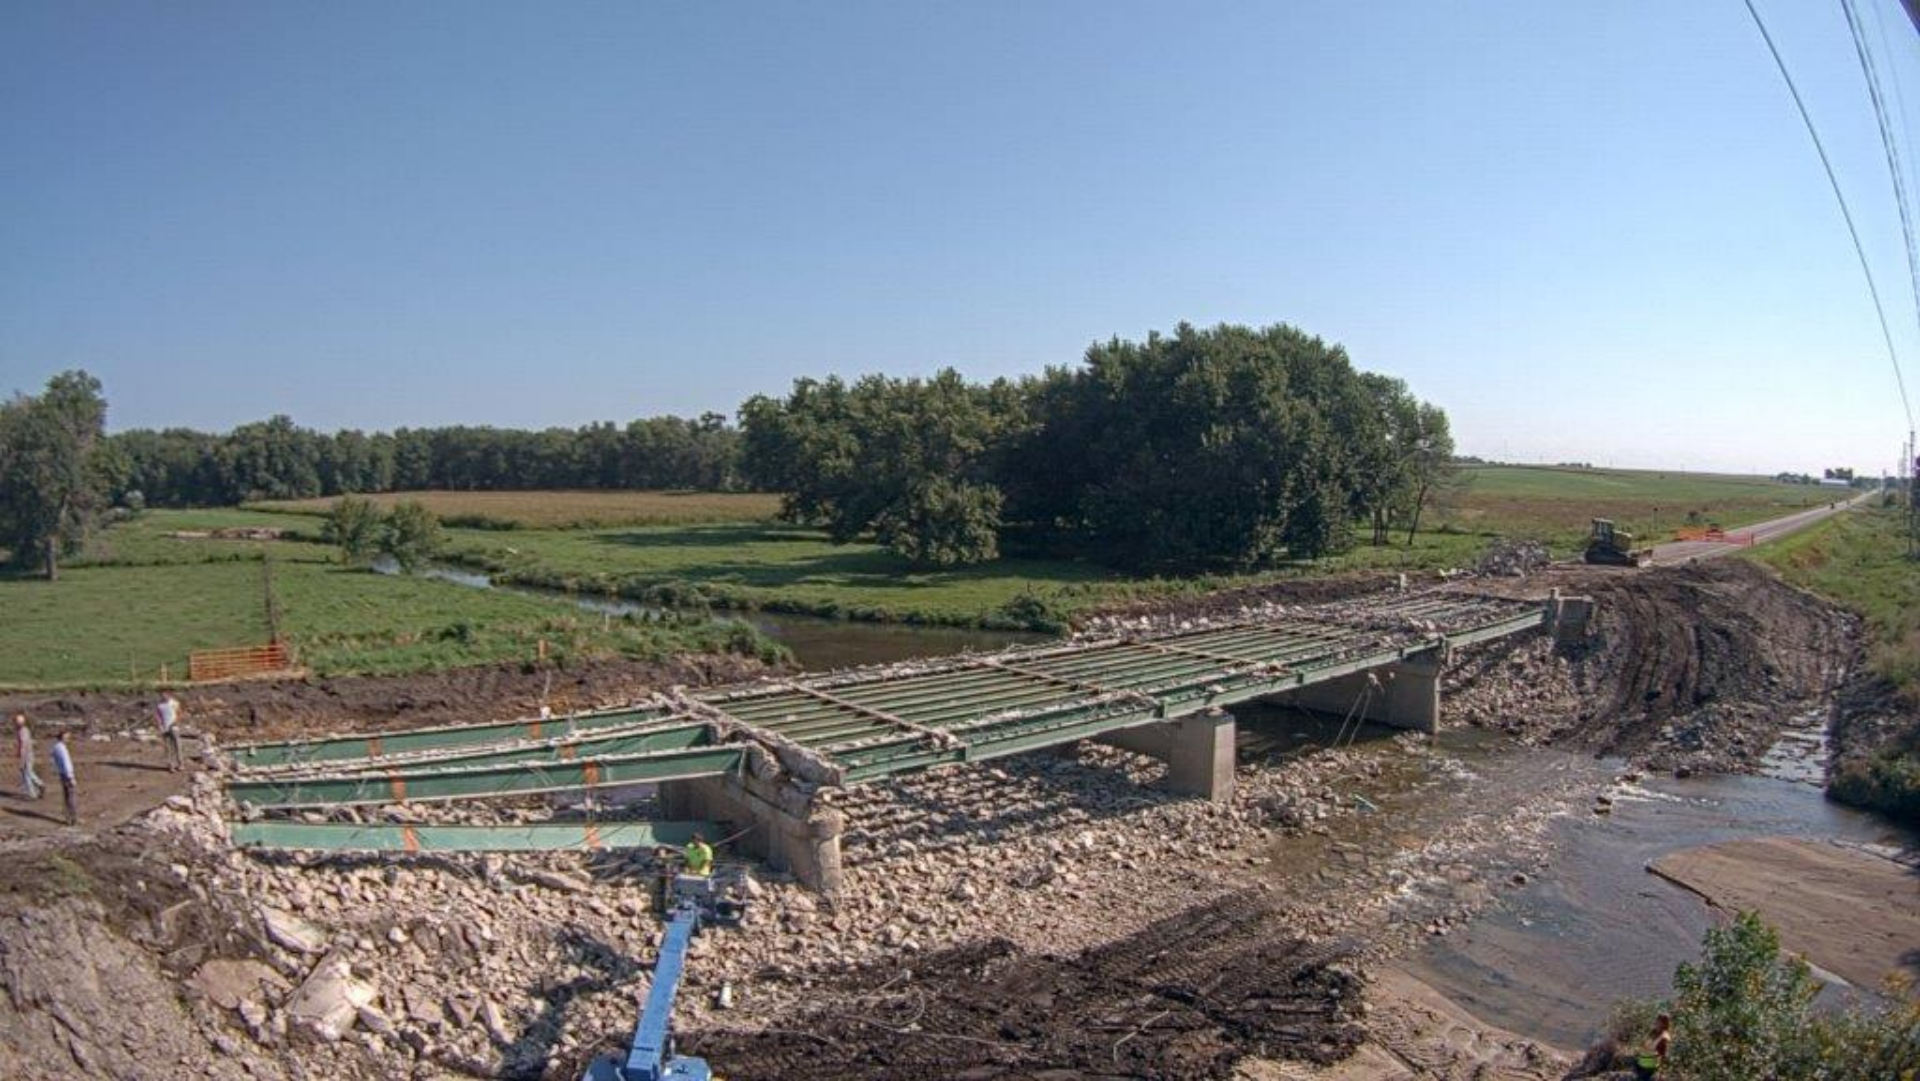
Is it fracture critical???

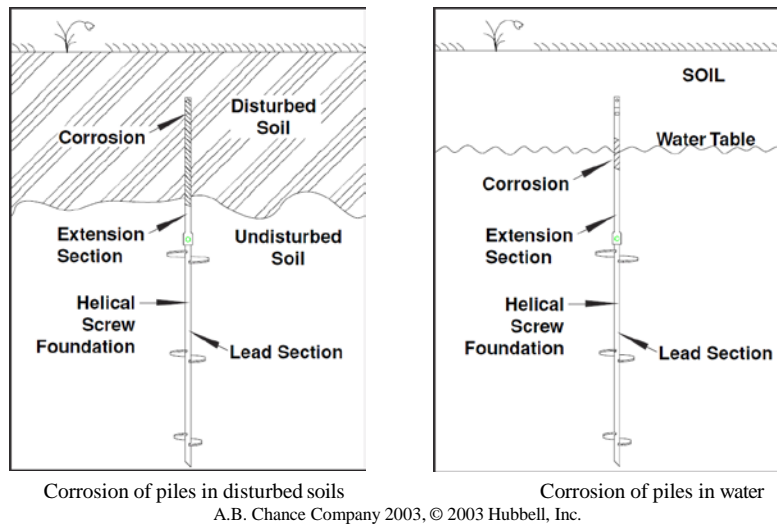
Figure 1. Corrosion of piles in disturbed soils and water

Figure 1 (left) illustrates the region prone to corrosion for piles immersed in disturbed soil.

Protective measures such as zinc coatings should be used on piles when corrosion may be a potential problem at a site. In the case of piles driven through disturbed soils, the protection should be applied to the critical region, which extends from the bottom of the pile cap down to about 3.28 ft (1 m) below the water table, as shown in the previous Figure 1 (right).

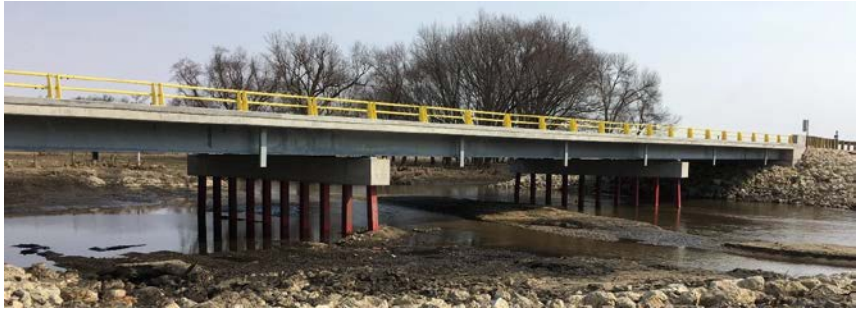
a) Bridge side view (with water level low)

Buffalo Creek is especially sensitive to high-total rain events. A significant amount of rain can quickly raise the water levels; thus, the piles are differently exposed to air, water, and river debris throughout its service life. Generally, the water level remains low as shown in [Figure 17-a](#). However, it is not unusual to see increased water levels like that shown in [Figure 17-b](#). When precipitation ceases, the water levels drop relatively quickly.

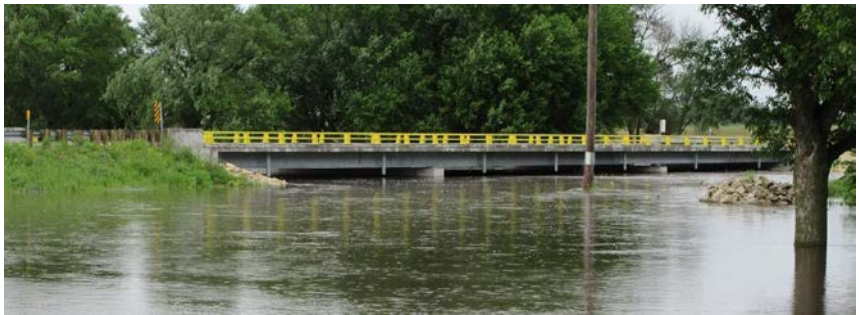
b) Bridge side view (with water level high)

The bridge is oriented in the east-west direction. Piles on the west pier were selected for the thickness measurements as shown in the previous [Figure 17-b](#). [Figure 18](#) compares the images of 10 measurement locations over three years from March 28, 2019 through May 3, 2021.

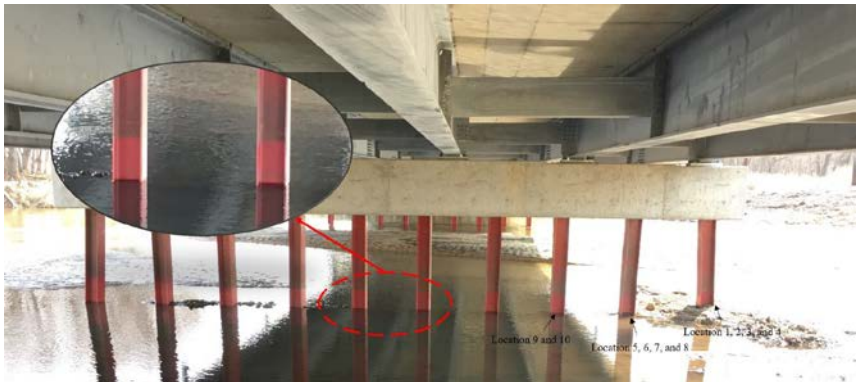
c) Galvanized and painted piles

The bridge is located on Buchanan County Road (CR) D-22 over Buffalo Creek. The bridge has three spans totaling 200 ft in length, and the bridge is 40 ft wide. The bridge superstructure consists of steel girders and a concrete deck. The superstructure bears on concrete abutments supported by painted galvanized piles at each end and two piers comprised of painted galvanized piles and concrete pile caps. The pile size used in each location is HP 10×57. [Figure 17](#) shows the bridge side view with specific focus on the pier structures.
